CONVERTIBLE ENHANCEMENTS NOISE, SEATBELT TRIM, OPERATE

Bulletin Number: 92-260-10
Issued: 16-jul-1992

SUBJECT: CONVERTIBLE ENHANCEMENTS - NOISE, SEAT BELT TRIM, OPERATING AND LEAK ISSUES

MODEL and YEAR: 1987-92 CAMARO

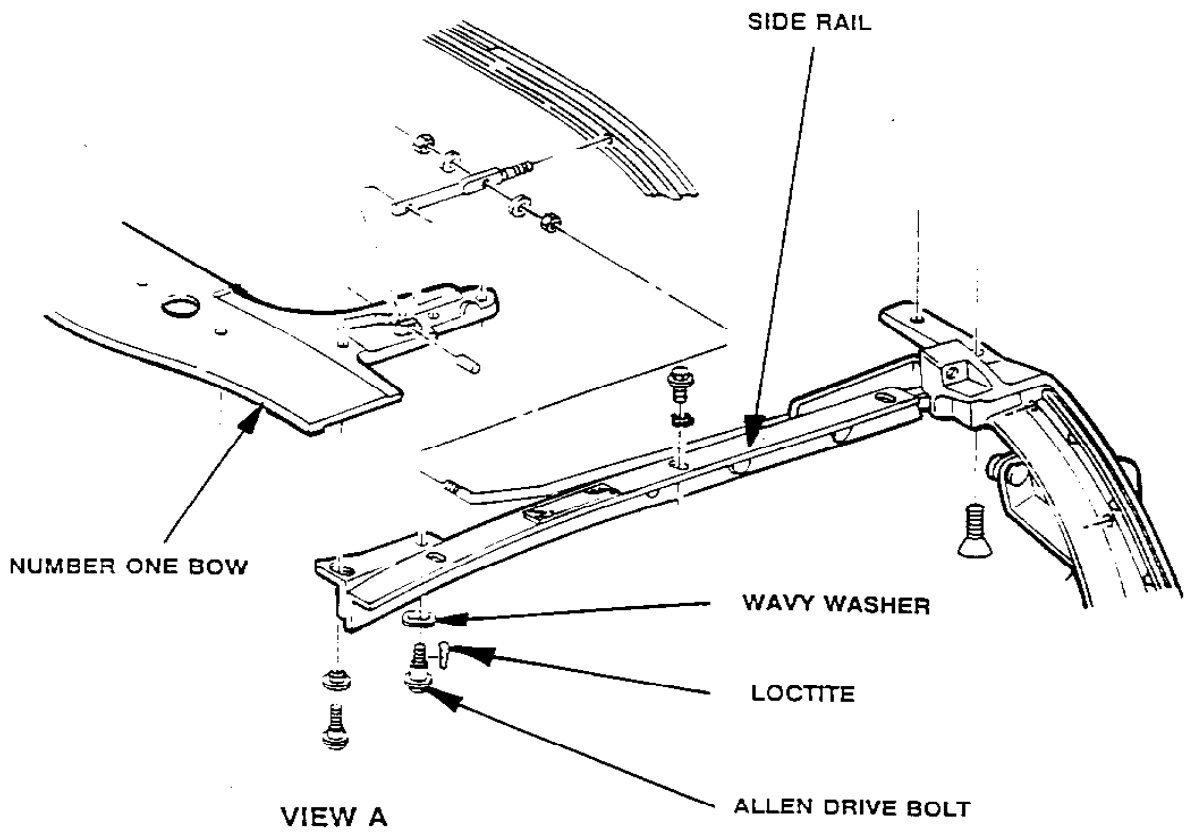
Figure 1

- (1) Rattle between the number one bow and the side rails.
- (2) Squeak between number one bow and number one bow garnish molding.
- (3) Rattle between number one bow boss and number two bow pivot link.

Add a wavy washer P/N 12520633 and *Loctite Removable Threadlocker #242 to provide tighter fit of number one bow and side rails.

1. Lower the top halfway. Refer to 1992 Service Manual Section 10-8 for removal of the number one bow garnish molding and remove.
2. Refer to Figure 1, left side view shown, right side similar. Remove Allen drive bolt, one per side, attaching side rails to number one bow.

3. Add one washer P/N 12520633 to each bolt and apply Loctite Removable Threadlocker #242 to the threads.
4. Reinstall bolts with washers and Loctite.

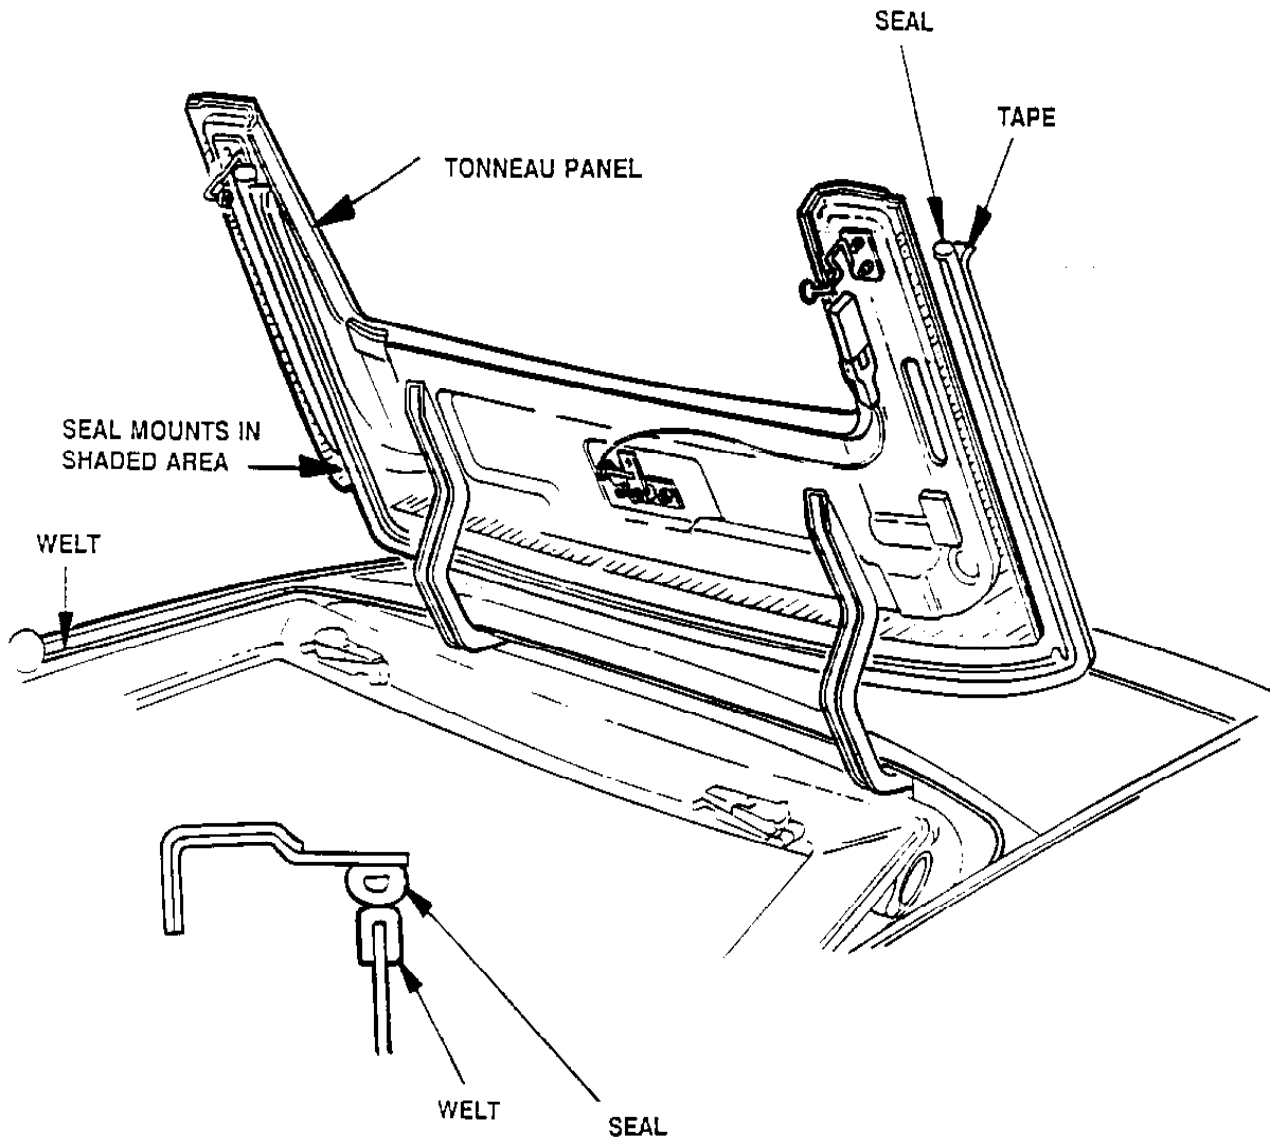
Figure 10

Tonneau seal moves causing water leak.

Replace tonneau seal with P/N 12511360.

NOTE: Tonneau seal should directly align with the trough welt to prevent water leaks. Center seal over welt.

6. Forward tabs of tonneau seal should align just past the edge of the tonneau panel.
7. Remove release liner from tape and loosely align new tonneau seal to the tonneau panel.
8. Close tonneau panel slowly and observe contact of seal so that it is over the center of the welt as shown in Figure 10.
9. Roll wall paper seam roller or equivalent over seal to bond it to the tonneau panel.
10. Lower and latch tonneau. Lower and latch number five bow.
11. Water test for proper sealing.

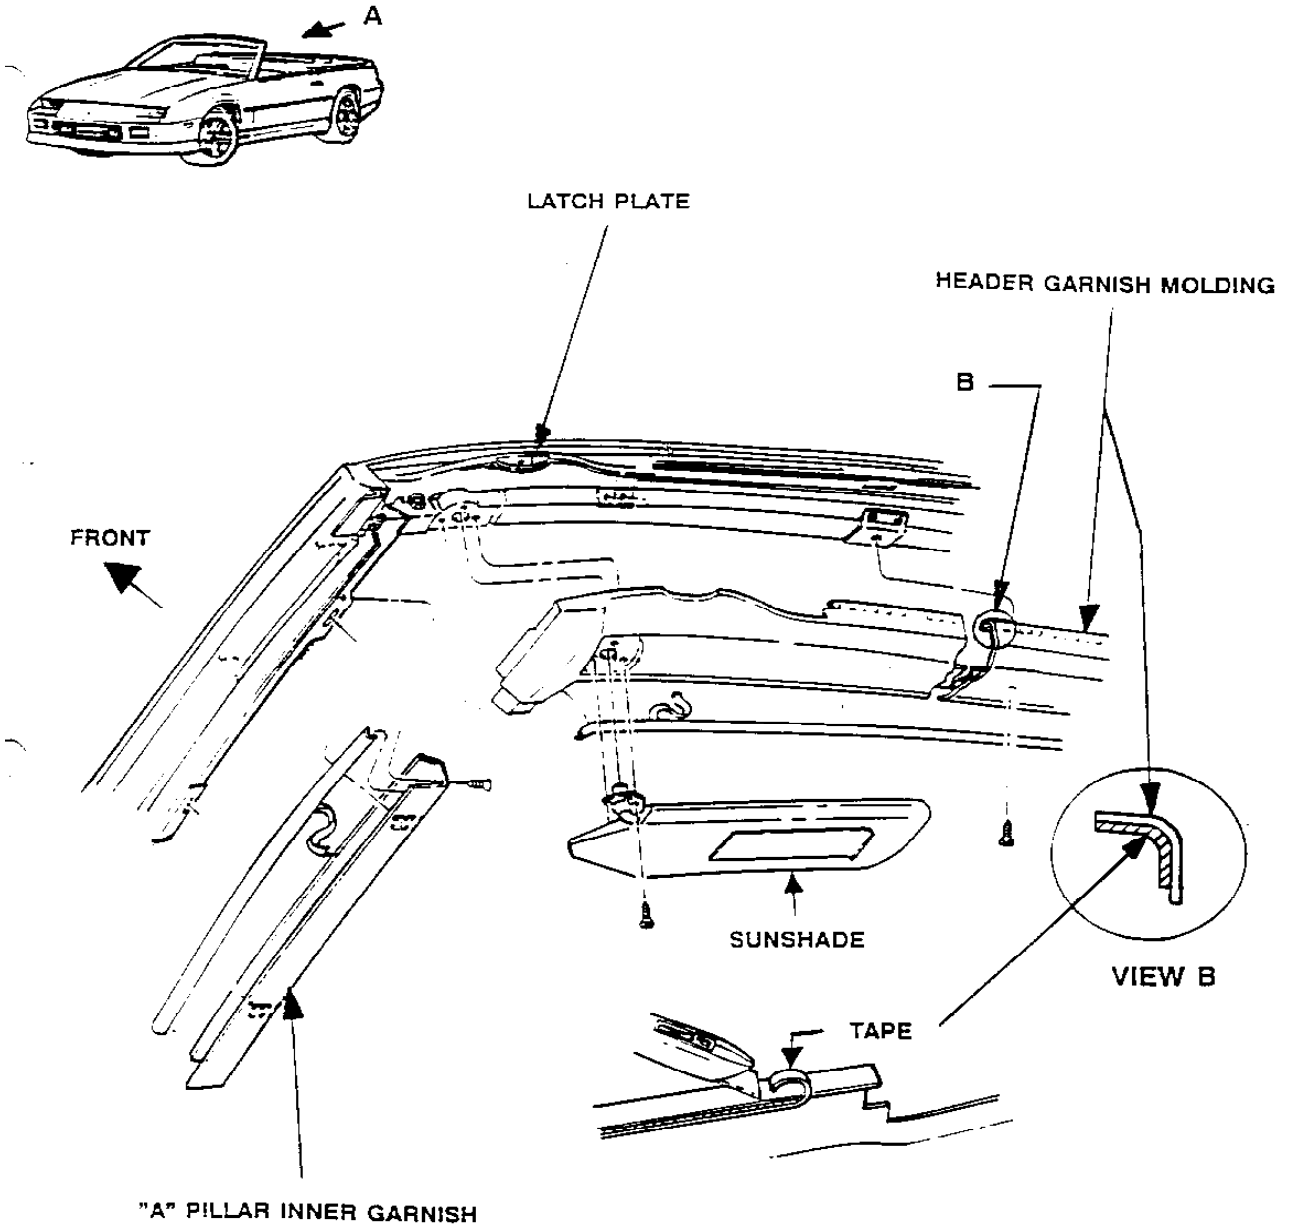
Figure 4

Squeak at header inner trim garnish molding.

Add 546 mm (21.5") of 3M #5430 Squeak Reduction tape to garnish molding.

1. Refer to Figure 4. Remove sunshade screws and sunshade.

3. Loosen "A" pillar inner garnish molding upper screw (left and right side).
4. Carefully shift header garnish molding rearward and out of the latch plate. Then slide header garnish molding up and out of the "A" pillar inner garnish molding.
5. Note Figure 4, View B. Apply 546 mm (21.5") of 3M #5430 tape to header garnish molding inner face between the latch plate locations.
6. Trim any tape protruding from the molding flange. Re-install the header inner trim garnish molding.
7. Install and tighten "A" pillar inner garnish molding screws. Carefully shift edges of header garnish molding forward and between edges of the latch plates while slipping upper lip to outside of header edge. Install and tighten header garnish screw.

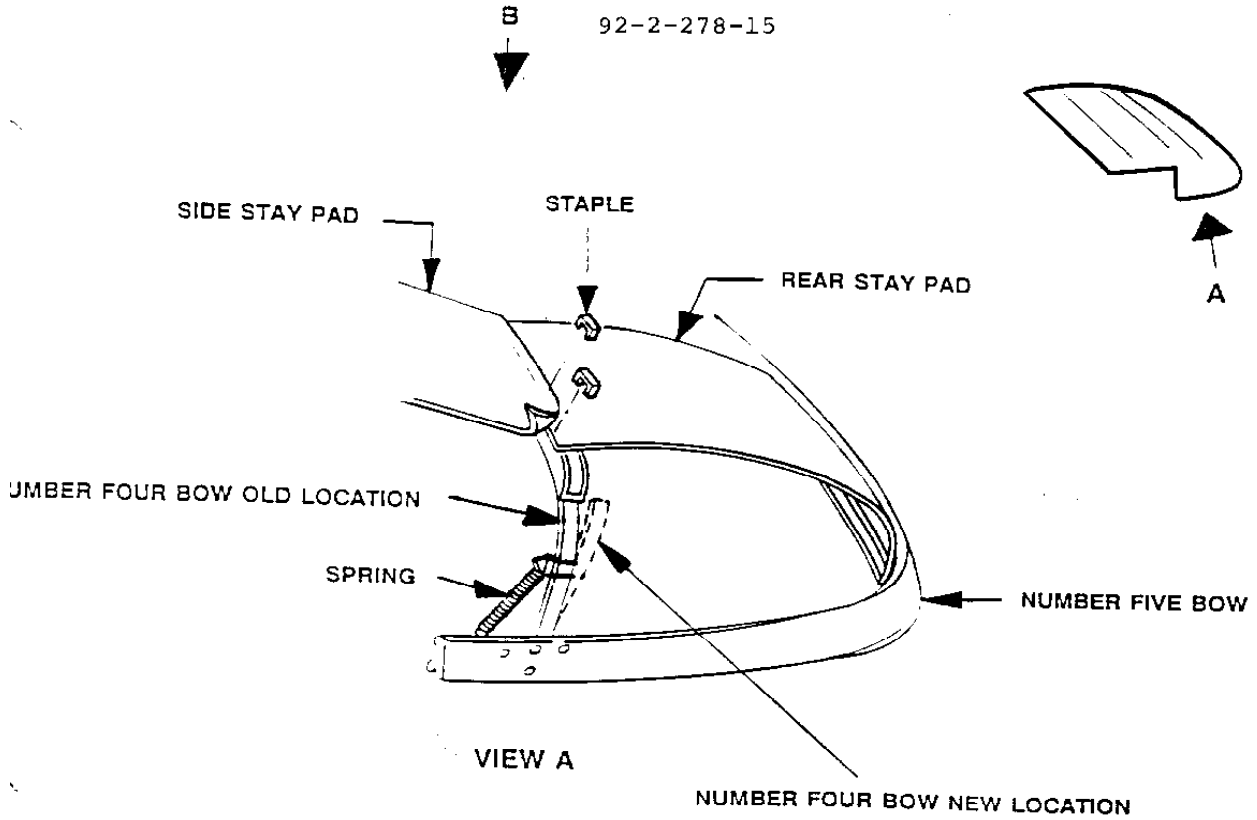
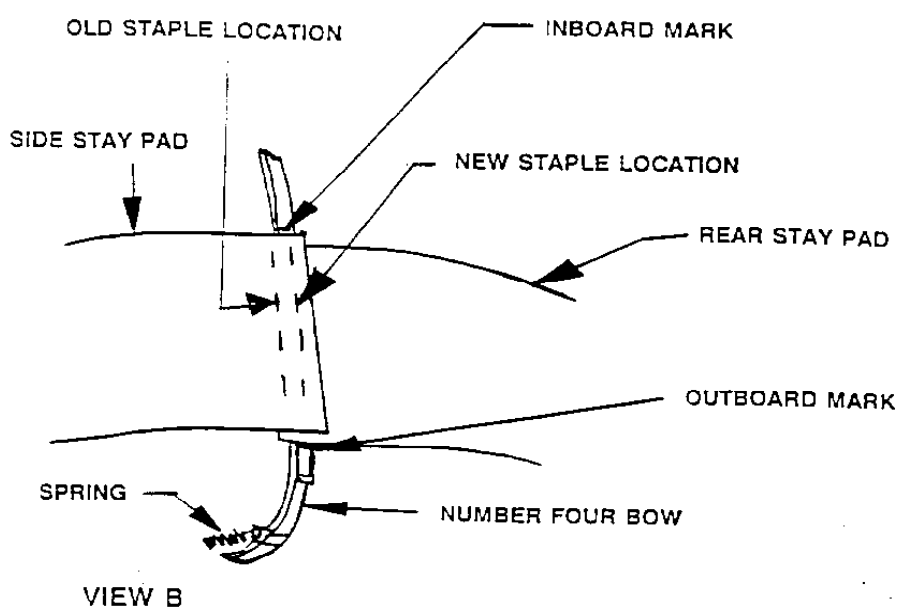
Figure 5

Number three bow snaps past number four bow when top is lowered and stowed.

Relocate number four bow. Refer to Figure 5.

7. This positioning will allow enough flexibility in the top cover to access the stay pads.
8. Mark the side stay pad staple locations with a grease pencil. Refer to Figure 5. Mark number four bow on the inboard side of pad. This will aid positioning of the pad at the new location.

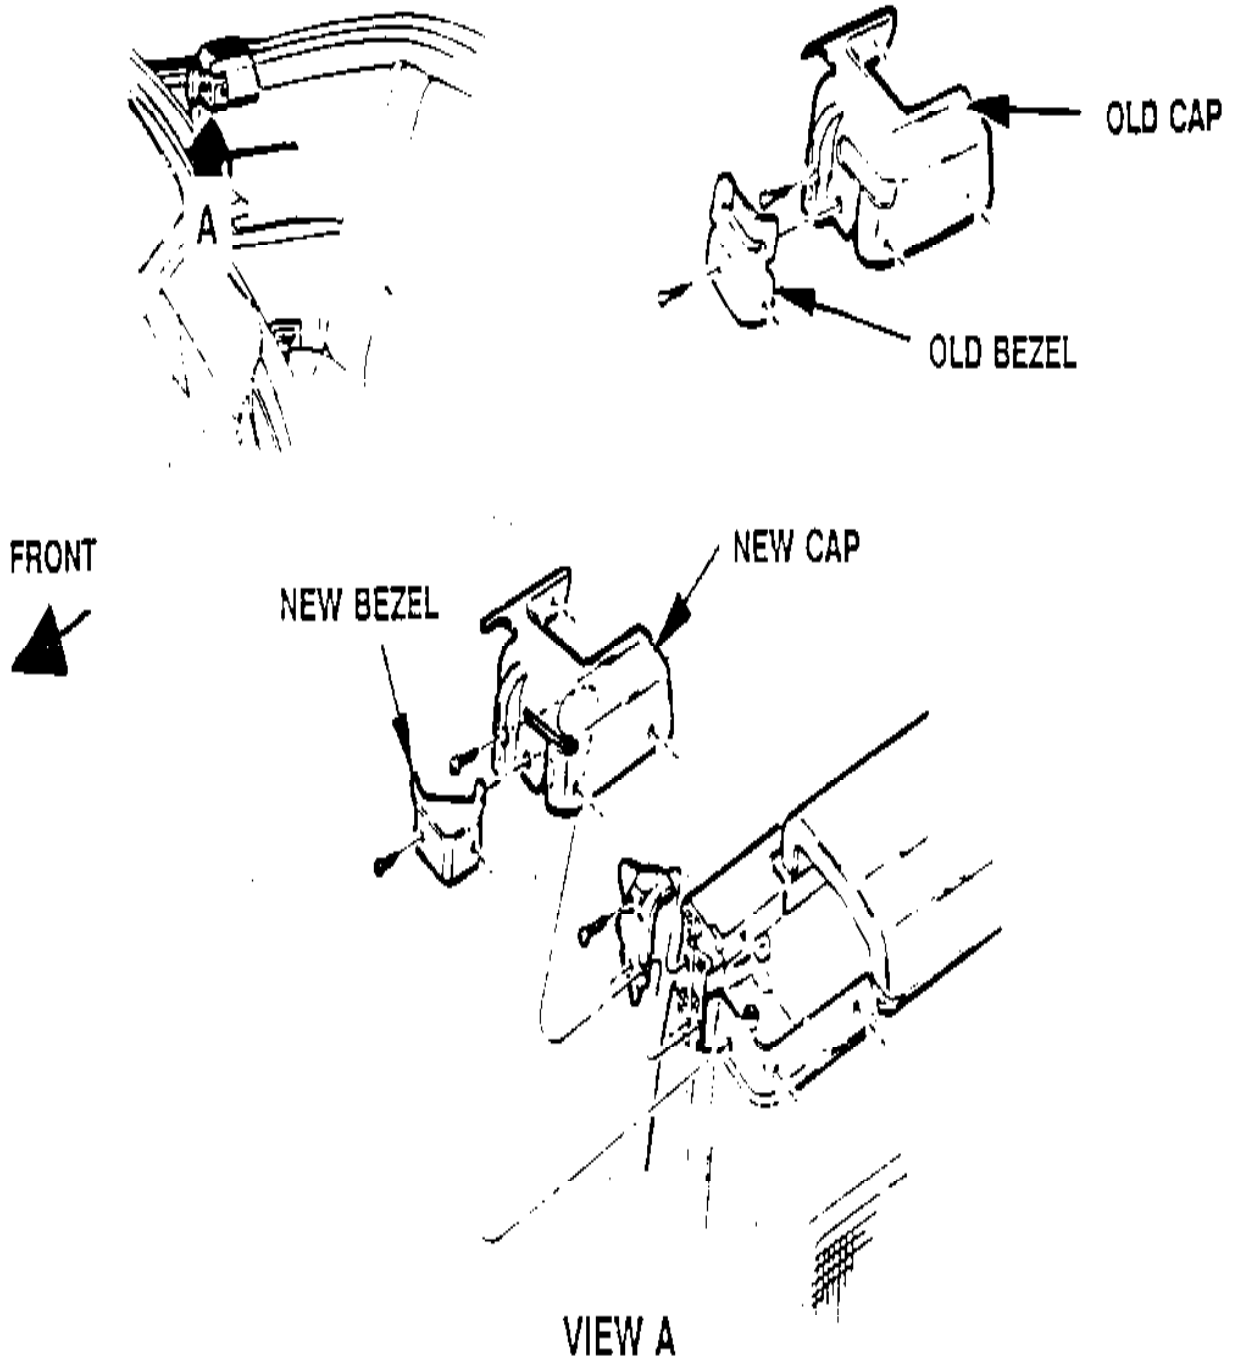
Figure 6

Seat belt twisting at B-pillar trim cap in vehicles prior to 1992 VIN 110434.

Replace both trim caps with P/N 12517754-5 right and left and bezels with P/N 12508710-11 right and left.

1. Completely lower convertible top.
2. Refer to Figure 6. Remove attaching screws. Remove old quarter trim caps and shoulder belt bezels.

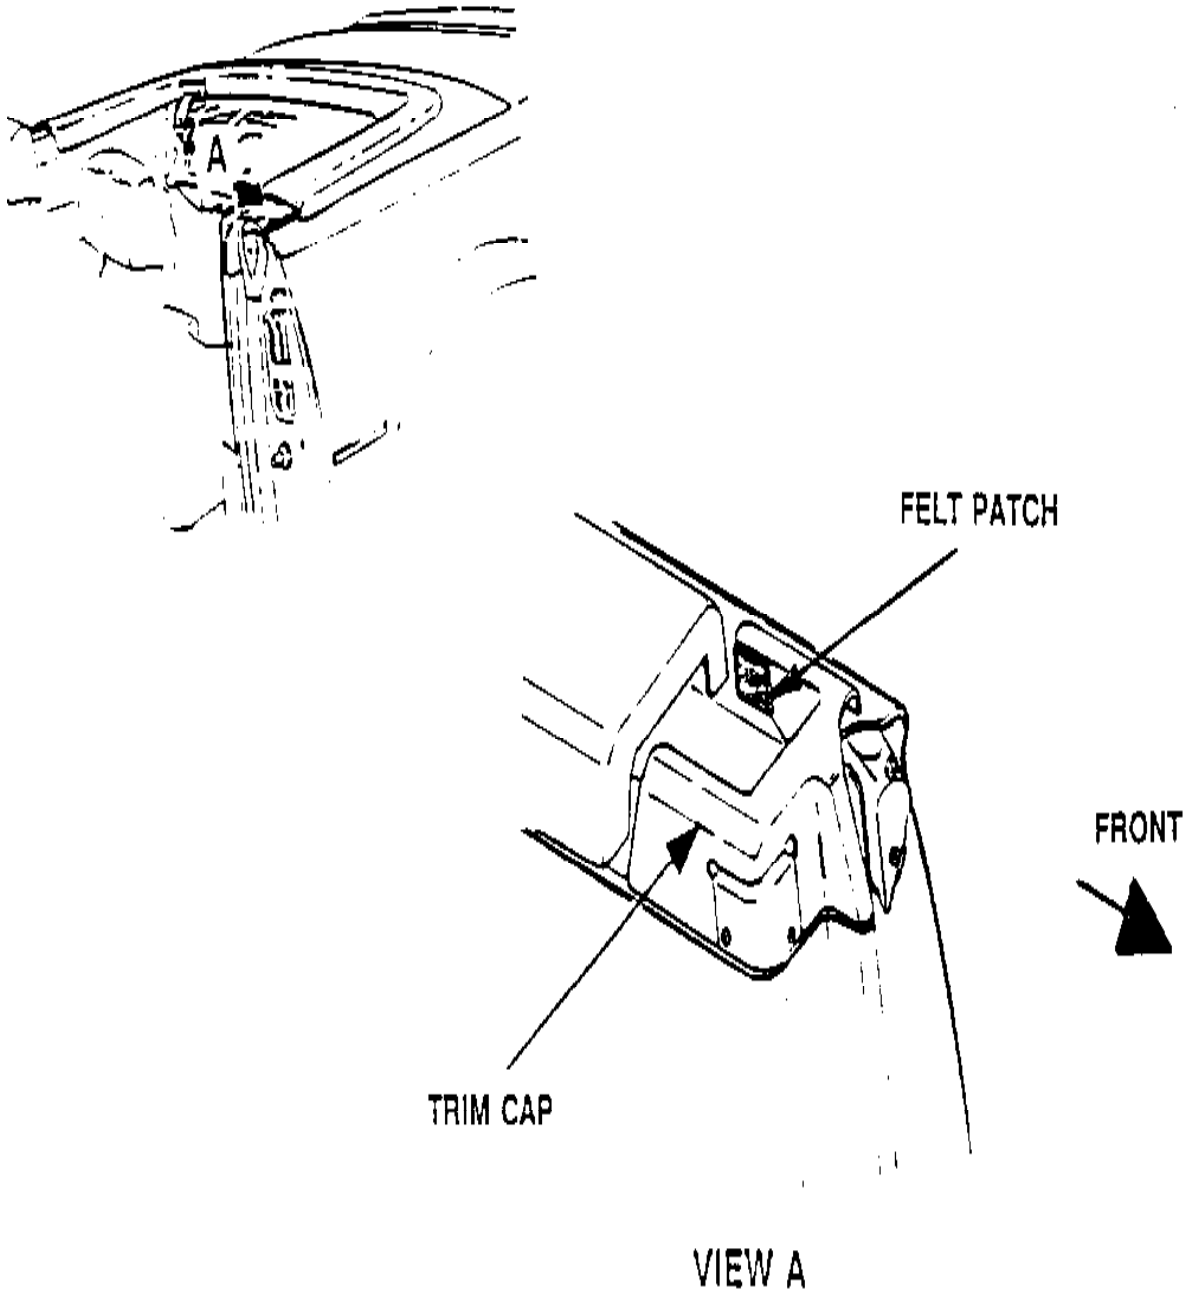
Figure 7

Convertible topstack folding mechanism rubs against B-pillar trim cap.

Add 25 mm (1") square piece of felt to both trim caps at rear of outboard surface. See Figure 7. The felt insulator material has adhesive backing and may be obtained from most local fabric stores. As an option use loop portion of 3M #06480 Scotchmate Hook and Loop Fastening System.

1. Lower top.
2. Install 25 mm (1") square piece of adhesive backed felt to quarter trim cap at rear of outboard surface. See Figure 7. Patch will overlap B-pillar trim cap.
3. Raise and latch top.

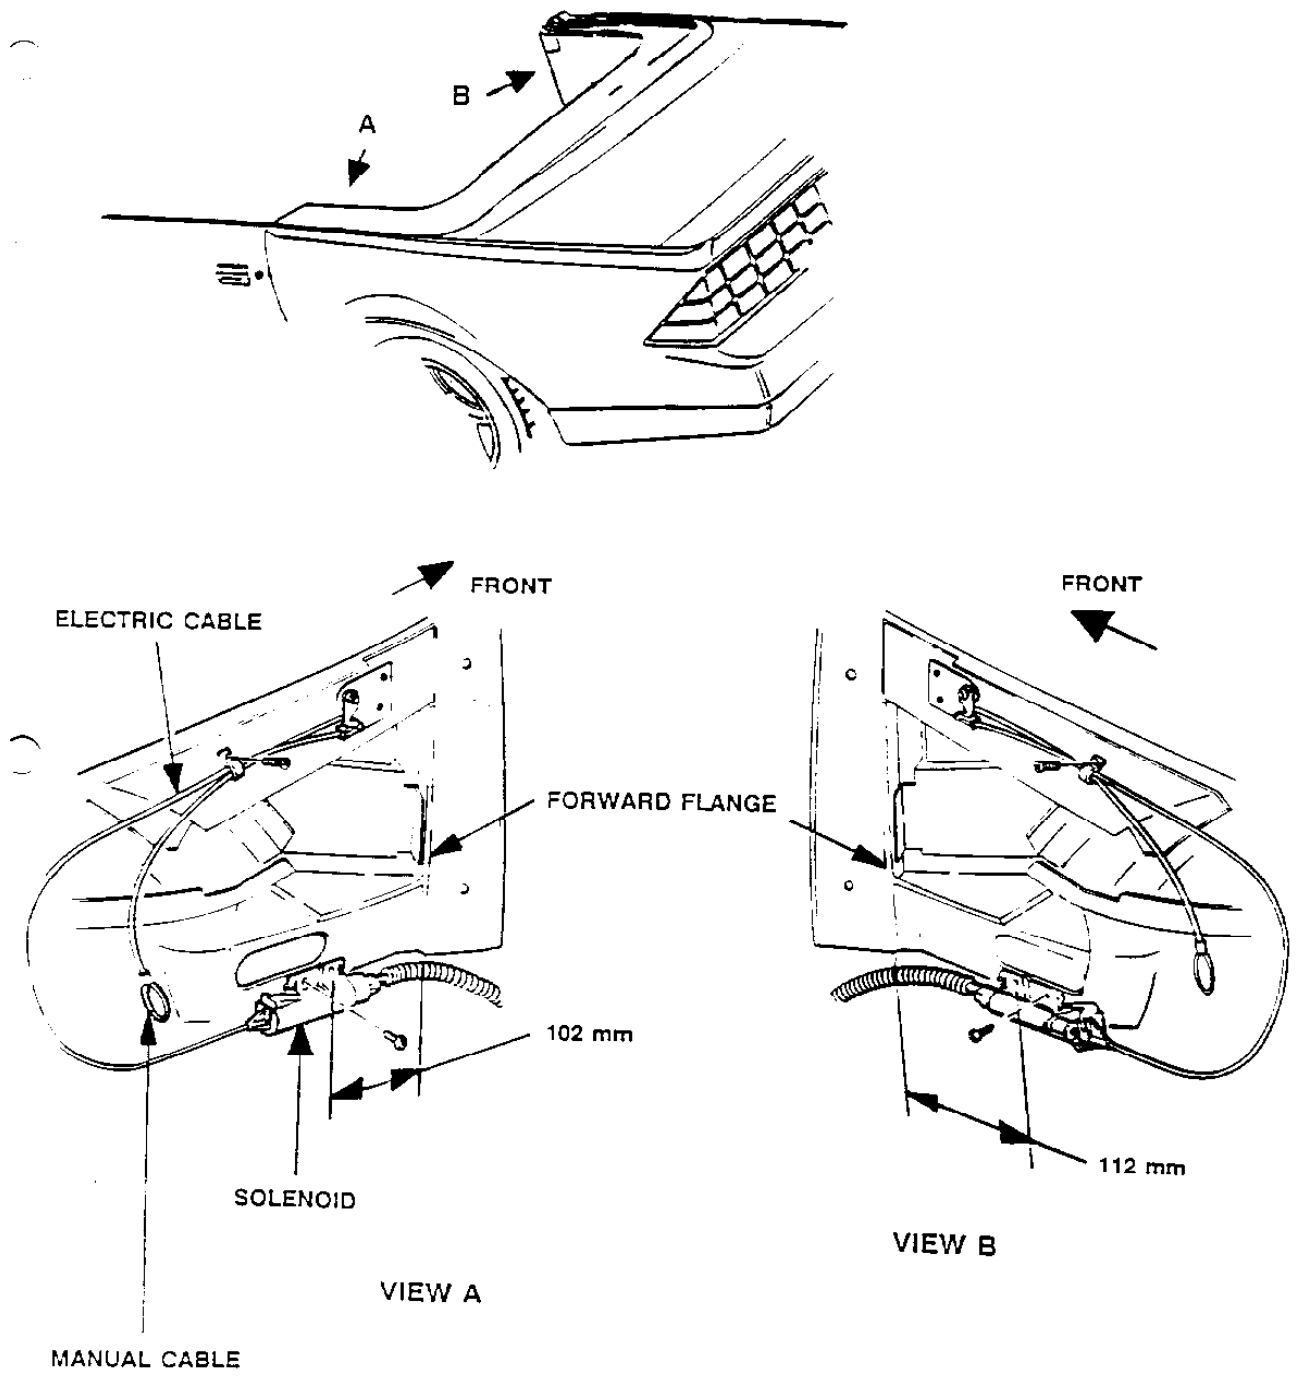
Figure 8

Tonneau (stowage lid) release sluggish or slow to release, prior to 1992 VIN 101062.

Relocate solenoid and use new cadmium or zinc-plated screws P/N 12517487.

1. Refer to 1992 Service Manual, Section 10-6 "Quarter Trim Panel (Convertible)", and remove panel.
2. Remove cable mounting screws and remove electrical cable from clamps. Leave manual cable attached to clamp.
3. Remove solenoid mounting screws and discard.
4. Refer to Figure 8. Relocate solenoid to new location.

NOTE: Check right or left orientation of bracket holes to mounting area. For best results, the solenoid forward hole is usually mounted on the inner panel 102 mm (4") left side and 112 mm (4.5") right side from the forward flange. Check clearances, cylindrical portion of solenoid must hang below the edge of the inner panel without interference.

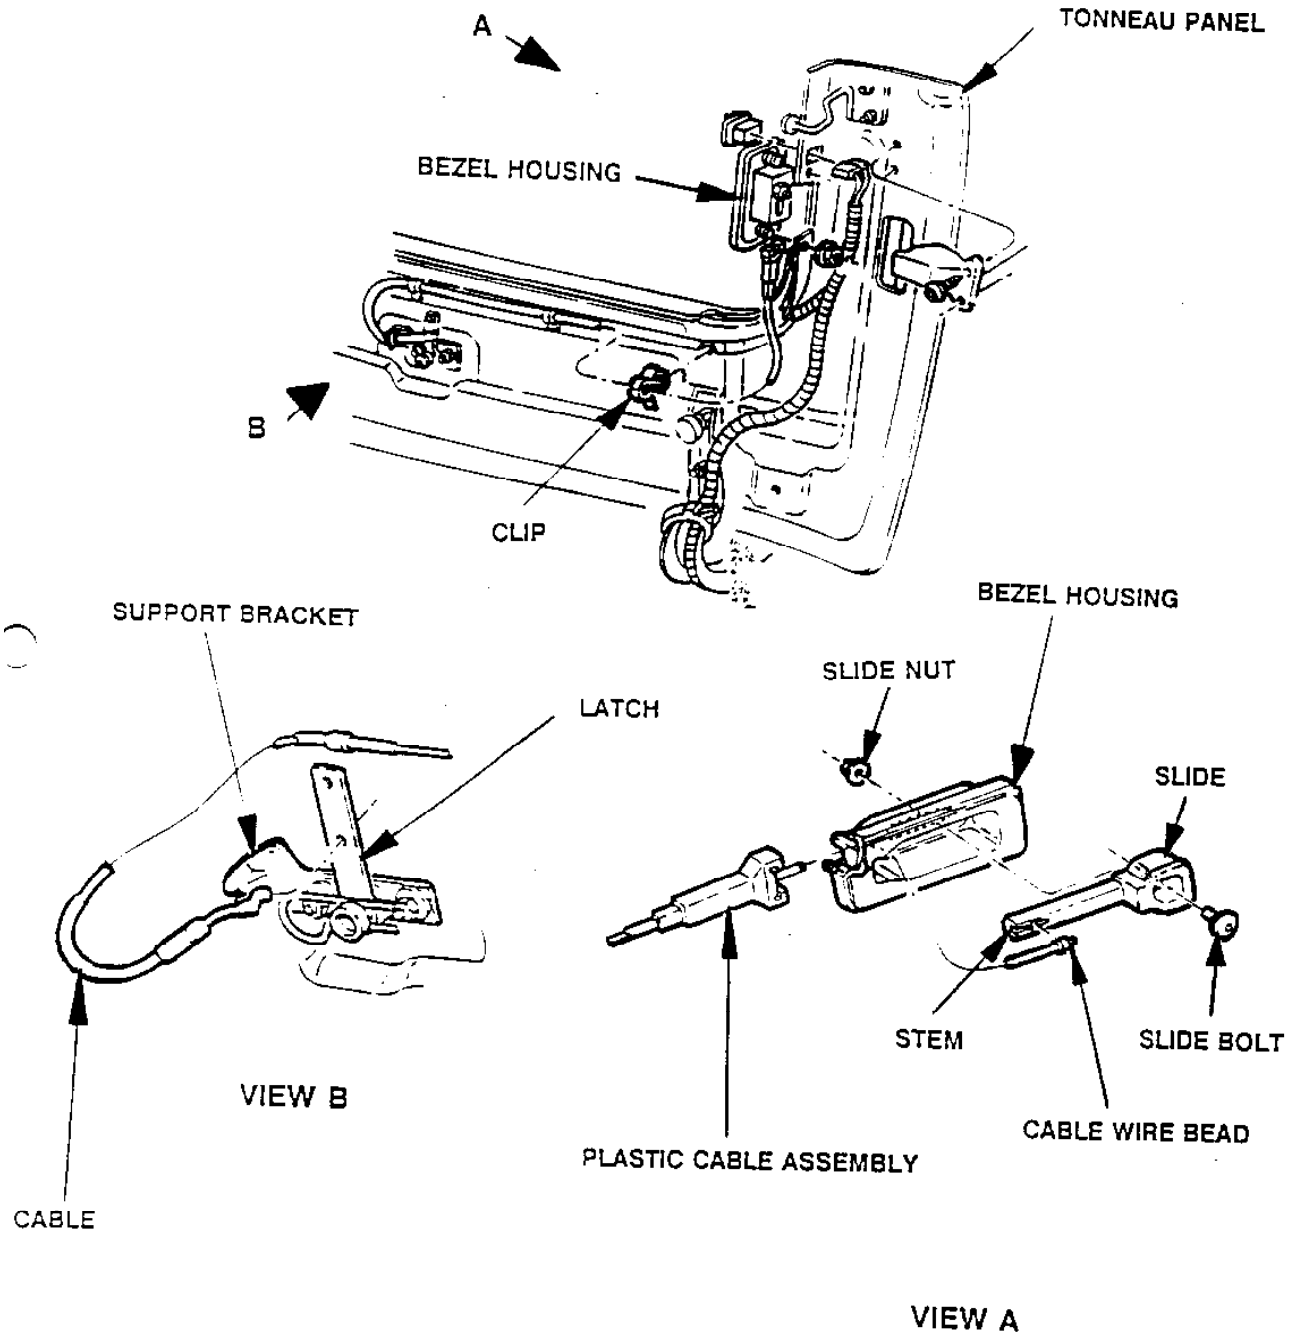
Figure 9

Number five bow release housing slide mechanism broken. 1992 VIN 189526.

Replace bezel housing assembly and cable assembly with kit P/N 12517351.

1. Release and raise number five bow to its vertical position.
2. Release and raise tonneau to its vertical position.
3. Refer to Figure 9. Remove cable assembly from latch hole in number five bow latch and cable support bracket.
