87-298-6E

Subject: CODE 33 MASS AIR FLOW (MAF) SENSOR VOLTAGE

Model and Year: 1986-87 CAMARO, CORVETTE WITH 5.0L OR 5.7L

(VIN CODE F, 8) ENGINE

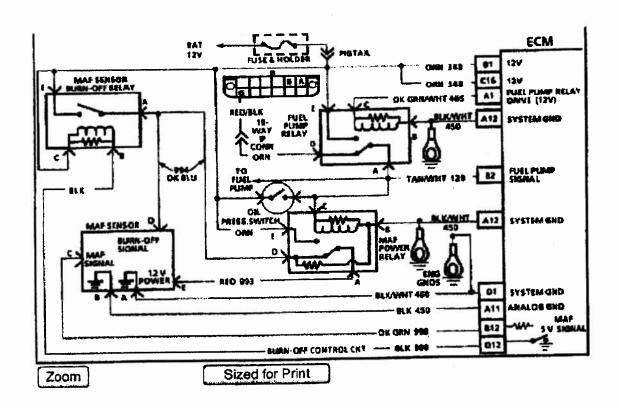
CODE 33 - MASS AIR FLOW (MAF) SENSOR CIRCUIT (GM/SEC HIGH)

The Mass Air Flow (MAF) sensor measures the amount of air which passes through it. The Electronic Control Module (ECM) uses this information to determine the operating condition of the engine, to control fuel delivery. The oil pressure switch or the ECM, through control of the fuel pump relay, will provide 12 volts for the MAF power relay which provides the 12 volts needed by the MAF sensor. The ECM provides a current limiting 5 volts on the signal line (CKT 998). The MAF sensor then changes the signal by dropping the voltage so that with low air flow the ECM sees a low voltage and a high air flow will cause the ECM to see near the 5 volts supply

Code 33 indicates ECM has seen flow in excess of 45 grams per second (above about 2.2 volts) for one second when:

RPM is less than 2000. Due to the 5 volts pull-up resistor in the ECM if CKT 998 becomes open, the ECM will see a high voltage signal and set a Code 33.

1. This test will determine if the conditions to set the code still exist.

With the Assembly Line Diagnostic Link (<u>ALDL</u>) terminal "G" jumpered to 12 volts, there should be 12 volts at the sensor. If no voltage is present, make sure that the fuel pump is running. If not, repair fuel pump circuit.

- If a burn off signal is present at the MAF sensor with the engine running, a Code 33 will set. Be sure no voltage is present on CKT 994 for the first 2 seconds after the ignition is turned "ON" or after the 2 second period.
- 4. The ECM sources a voltage (4-6 volts) to the MAF sensor on CKT 998. This test checks for that voltage.

By jumpering the fuel pump test terminal ("G" terminal of ALDL) to 12 volts, the MAF sensor will stay powered up and the signal line should see a low voltage, less than 250 mV or low grams per second on a "Scan" tool. By wiggling the related wiring the intermittent may be detected. Also, an erratic signal with the engine running may indicate faulty wiring or components.
