BW 9-bolt positraction cone repair

Article & photos by 88
350 tpi formula, GM Tech,
Editing by Duck [Hawaii],
Rev 5, Nov. 30, 2004

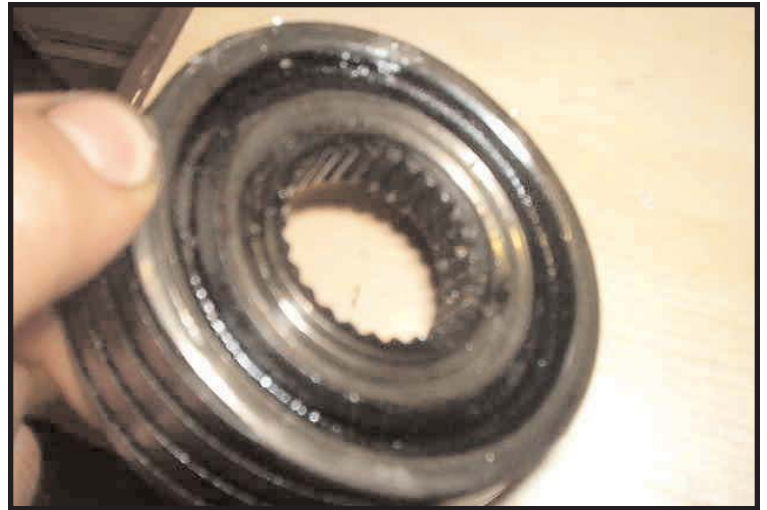
Worn out cone -- Severely worn cones with raised centers and indented wear rings can't be fixed.

Inspect the cone smaller end to determine if it is fixable or not. The *Worn out cone photo* shows a raised center and indented wear ring (this one was worn so severely that the groove worn in it was

deeper than where the full axle spines start). The reason badly worn cones can't be fixed is because turning the cone on a lath until the whole inside end is the same depth as the badly worn

groove, would result in so much material being removed from the splined area that it would only leave a very thin splined cone that would wear out very quickly or break. This is shown in the photo of *inside the case housing*.

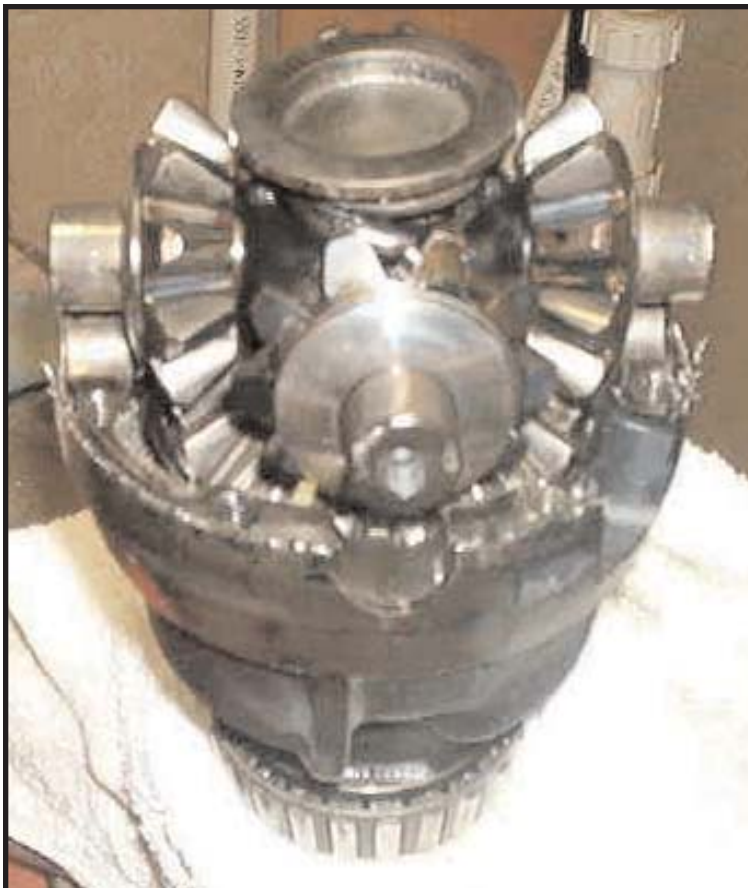
Top half taken off -- The cone and gear are now only held in by gear lube and may drop out if moved.

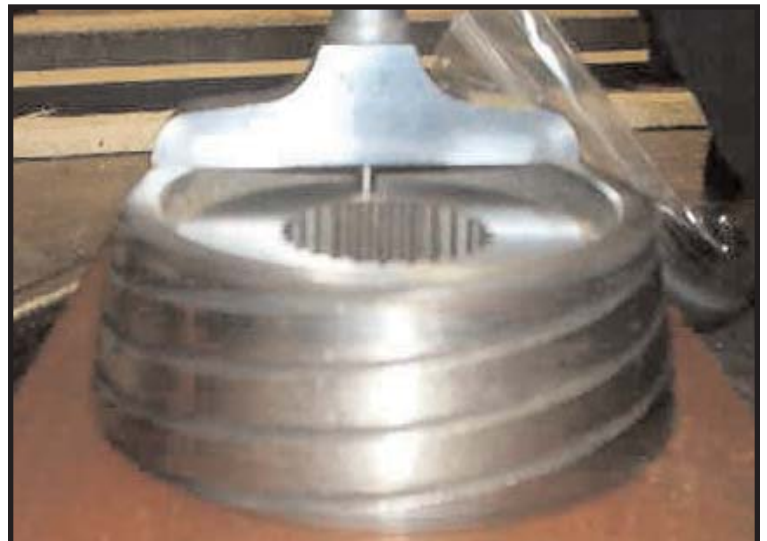
Depth -- Measure the depth before turning the end in the lathe to keep the same dimensions when the job is completed, not much was taken off the cone ends.

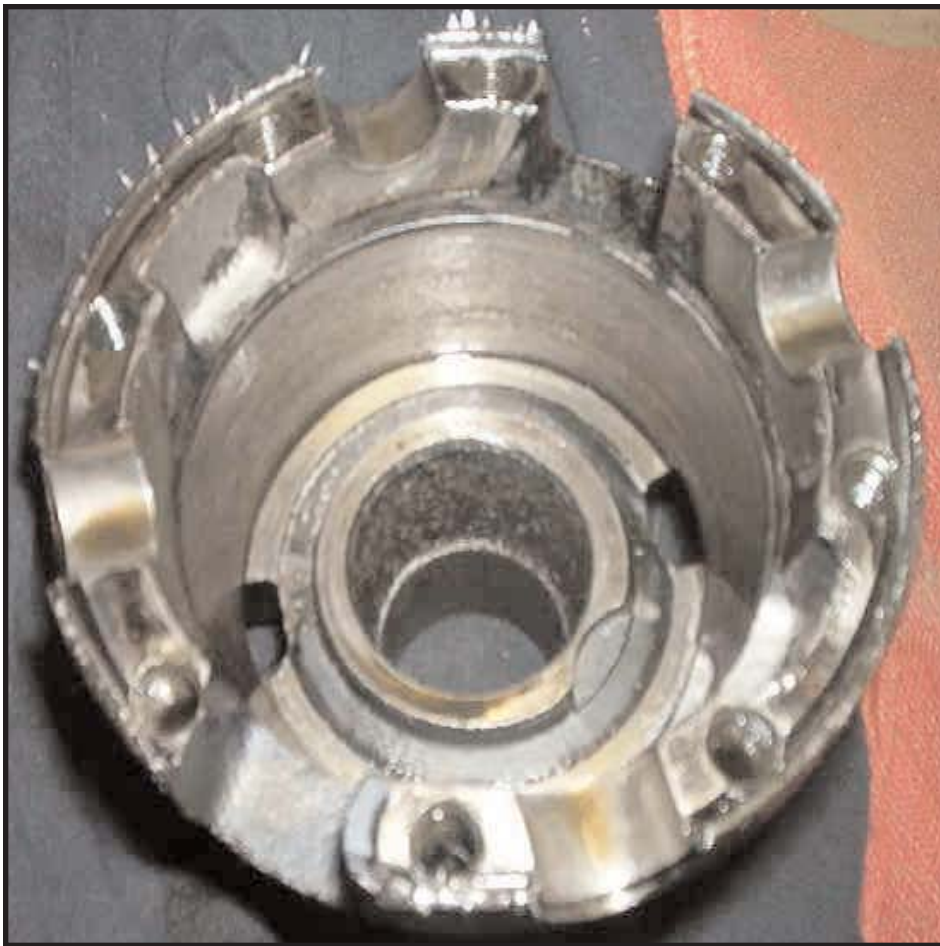
Inside the case housing -- shows why worn cones would quickly bottom out.

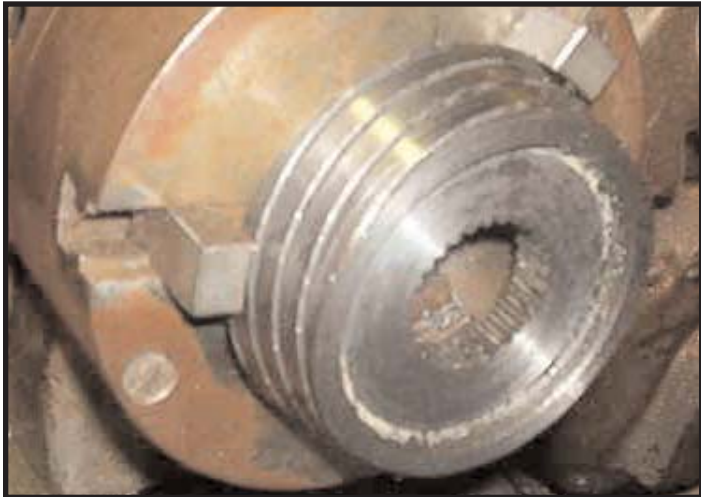
Chucked -- during this repair, not much was taken off the cone on the lath.

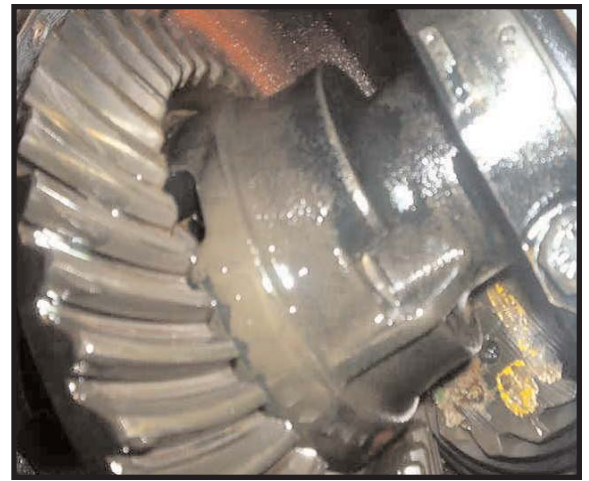
In car -- Cone is close, not bottomed.

keep the same dimensions when the job is completed. The photo *Incar* shows the cone end is close to the case but, does not bottom. This allows the cone to function correctly by moving down and retain full traction holding power by using the wedging action of the cone to the case).

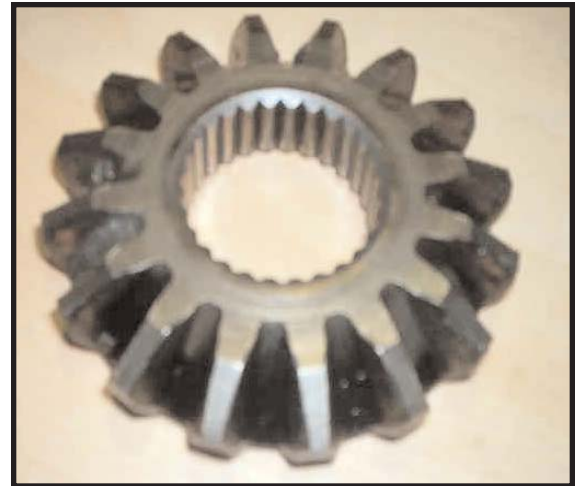
At right, one of two large side gears.

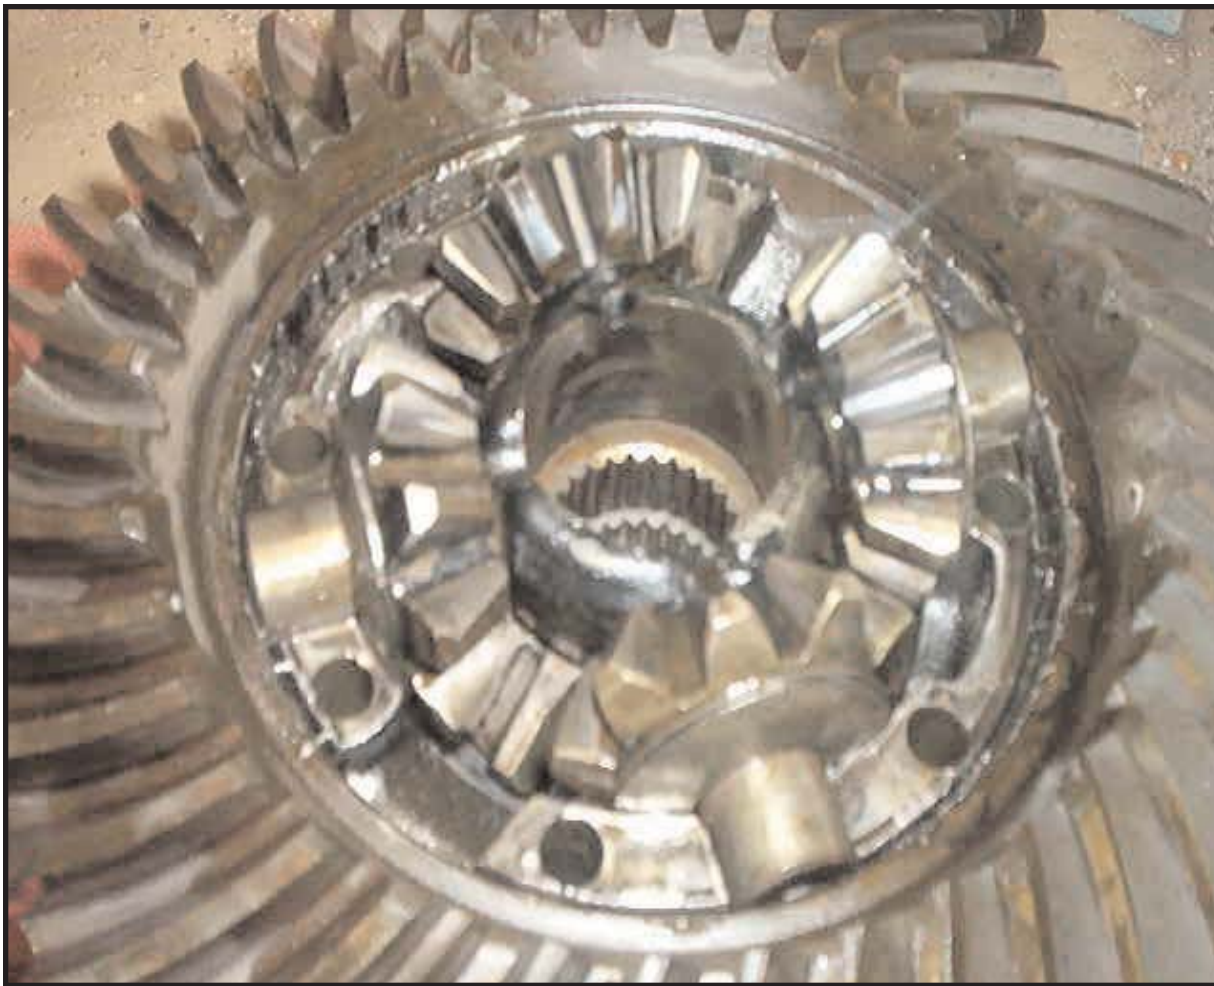
Shimming -- Spider gears in the case during the shimming process. Shims are inserted in .005 steps to obtain the desired shimming. Make sure the shimming doesn't create pressure on the gears.

Shims are inserted in .005 steps to obtain the desired clearance when placing the spider gear cross in the case to make sure it fully seats without any pressure from the shimming.

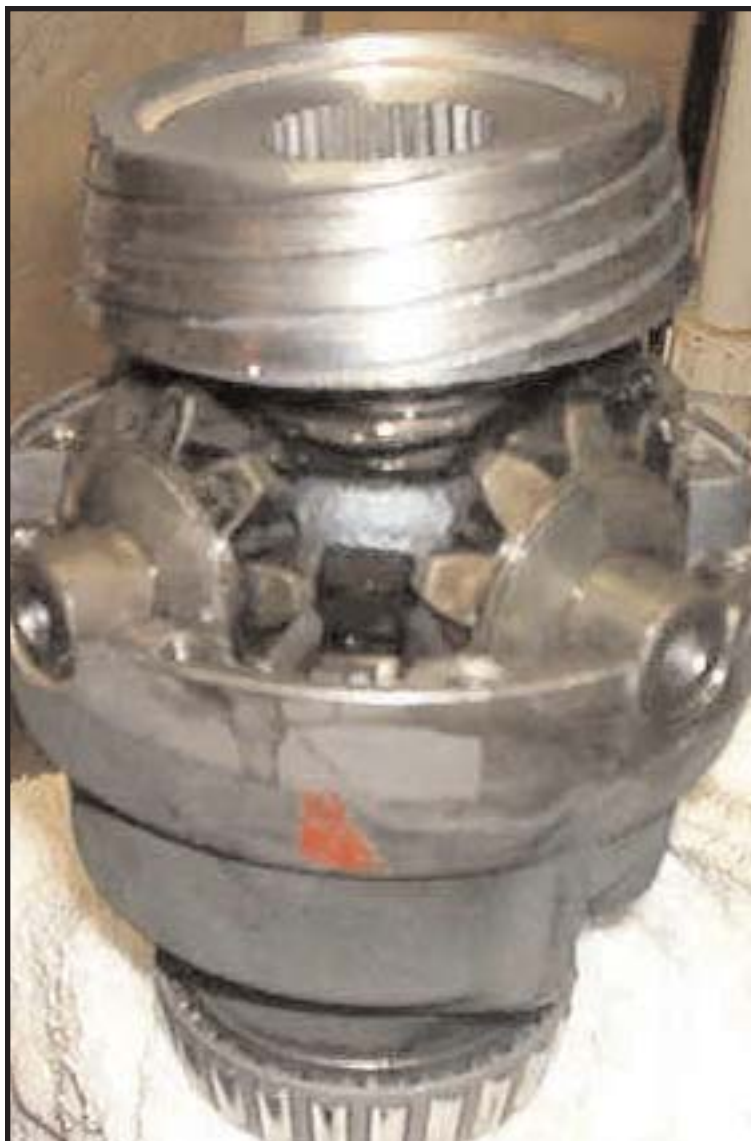
Reinstalling parts

Both cones were processed in the same way, then everything was cleaned three times to remove lots of metal residue, then everything was stacked back up on the axle to center the side gear on the axle and the shimming was double-checked, then the bottom half was reinstalled [see photo *Reinstalling*].

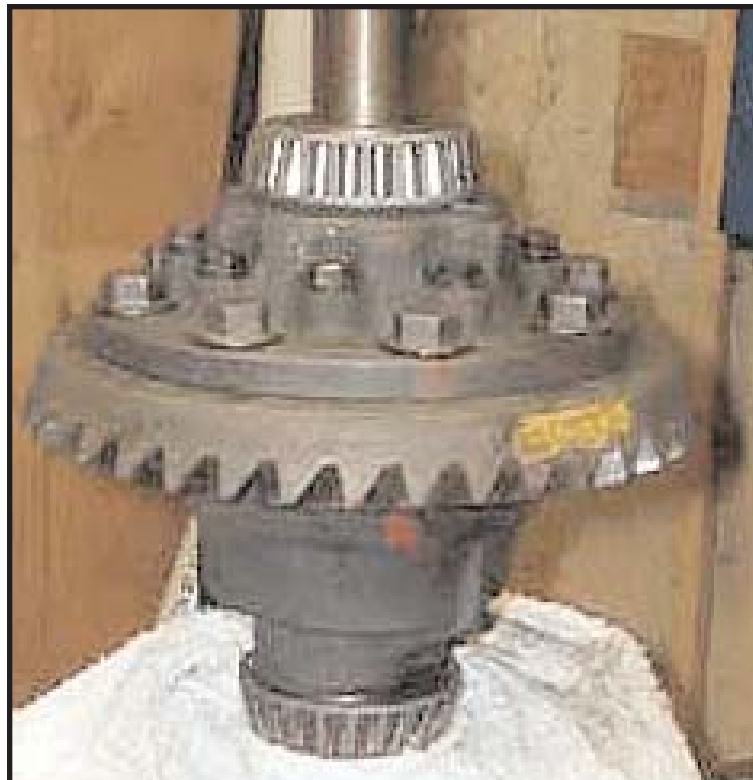
Starting Bolts --

The top case half is then placed on top, making sure the case marks are aligned and all the retaining bolts tightened by hand a few turns. Next the second axle is placed in the posi and with the assistance of a second person the case half bolts are tightened down by hand in a star pattern [see photo

starting bolts]. When the case is bottomed the bolts are tightened to specs and the axles can then be removed. Check again to make sure everything is clean and finally after installing the carrier back into
