## ***GM No-Crank in vehicles with Vehicle Anti-Theft System (VATS)***

## Temporary Fix for GM No-Crank in Vehicles with Vehicle Anti-Theft System (VATS)

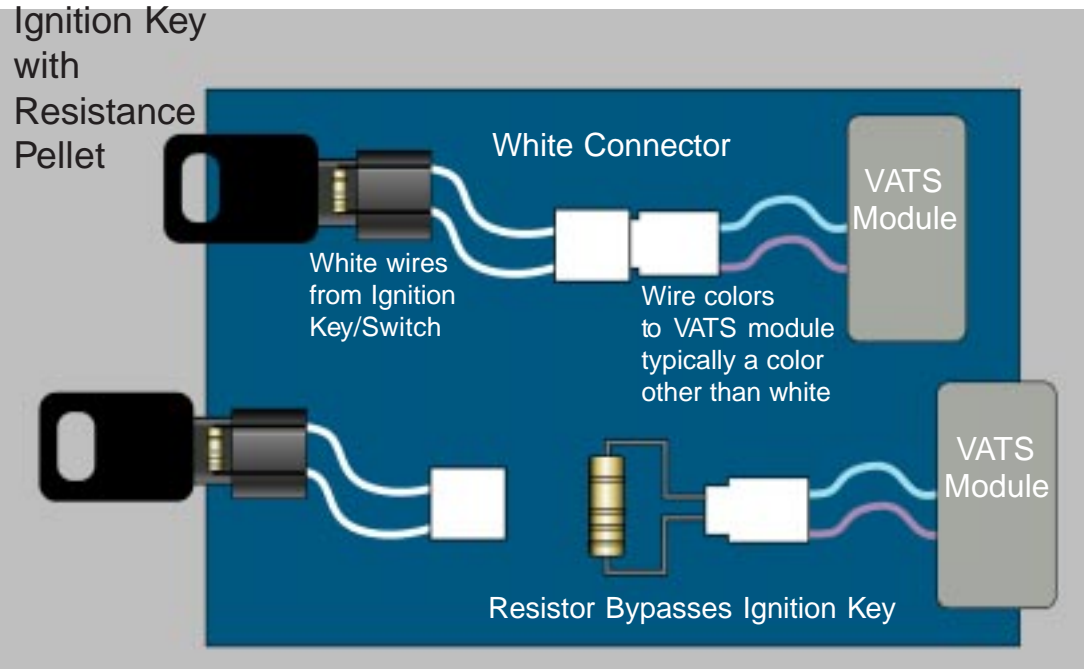
Experience suggests that VAT ignition key failures are less common than no-cranking conditions caused by switch/harness failures.

- Remove the ignition key and measure the resistance of the pellet in the key.
- Drop the steering column bezel and disconnect the white wire connector.

- Connect your sensor simulator across the terminals of the harness connected to the VATS module and “dial in” a resistance equal to the key pellet resistance, or simply insert a fixed resistor of the correct value.

This bypasses the key/harness and, in many instances, it will allow you to start the vehicle and drive it into the shop.
