Replacing the Flip Rods in a 89-92 F-Body Convertible:

By Lon Salgren
lonsal@adelphia.net

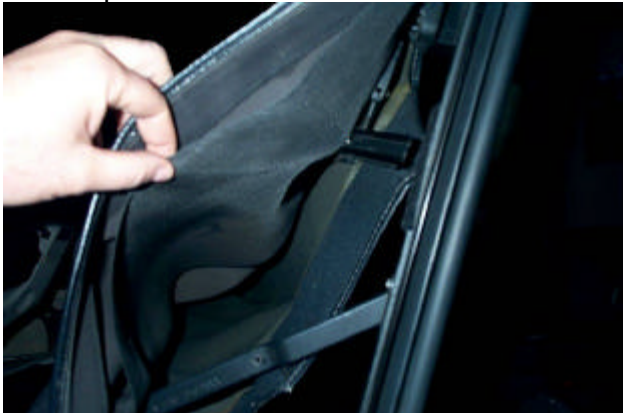
Figure 1: Shown with no flip rod. Notice the #2 bow is still nearly resting on the side seal (top lining pulled back to show the #2 bow).

A: The symptoms of a broken or missing flip rod are the top will not retract properly. The top will fold-up short and want to hit the back of the rear seat (if it is upright).

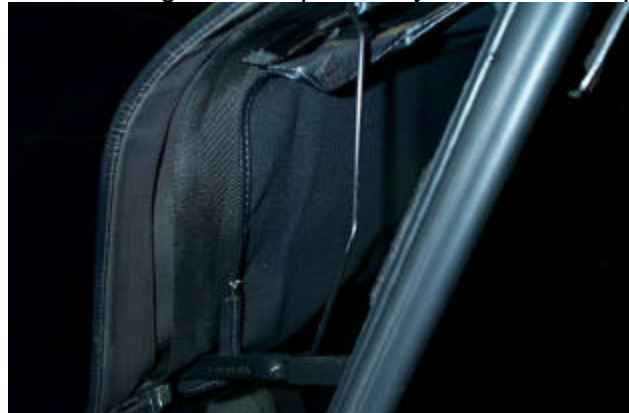
Figure 2: Shown with flip rod installed. Notice the #2 bow is now raised by the flip rod as the top is lowered.
